RECRUITING (BABIL VOLUNTEER)
CENTER
AL HILLA, IRAQ

SUSTAINMENT ASSESSMENT

SIGIR PA-06-089
APRIL 17, 2007

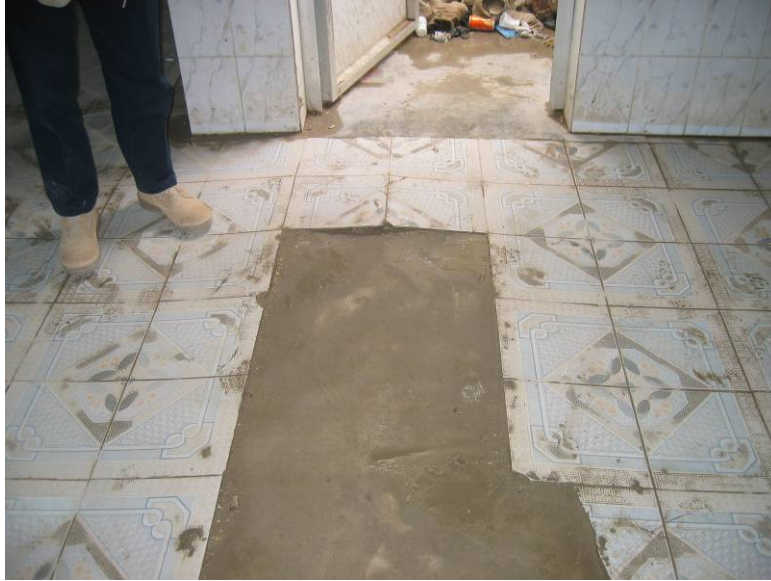
Two bathroom floors buckled causing damage to concrete and tiles. At AFCEE’s request, Weston’s subcontractor visited the site on 17 February 2007 to assess the damage to the floors. The contractor believes that the buckling resulted from water swelled soils surrounding the drain pipes due to wastewater leaking from damaged lines. The contractor noted that because the end user never evacuated the sewage holding tank, effluent backed-up in the drain lines and leaked into the ground beneath the floors. The contractor also stated that drain lines may have been damaged when the end user replaced a western style toilet.

SIGIR concurs that the buckling is likely caused by water leaking into the soil causing it to swell and exert upward pressure on the floors. We also agree that the likely cause for the leakage is failure to evacuate the sewage holding tanks which causes backup through the drain lines. The problem would be mitigated if the sewage holding tank were properly evacuated; however, force protection barriers and internal walls prevent pumping trucks from accessing the tanks. Site Photo 1 shows the buckled floors and tile damage. Site Photo 2 shows the overflowing sewage holding tanks draining raw sewage to the adjacent lot. Site Photo 3 shows the jersey barriers blocking the only vehicle access to the building rear.

Site Photo 1. Bathroom floor tile damage caused by buckling from ground swelling

After being notified of the problem, the contractor committed to provide an access route to the sewage holding tank and have it evacuated for the first time. The IAF will be responsible for subsequent evacuations. The contractor also agreed to repair the buckled floors and damaged drain pipes.

2. The contractor has committed to providing an access route to the sewage holding tanks and evacuating them for the first time. The IAF will be responsible for subsequent evacuations. The contractor will also repair the buckled bathroom floors and repair drainage pipes damaged by the occupants.

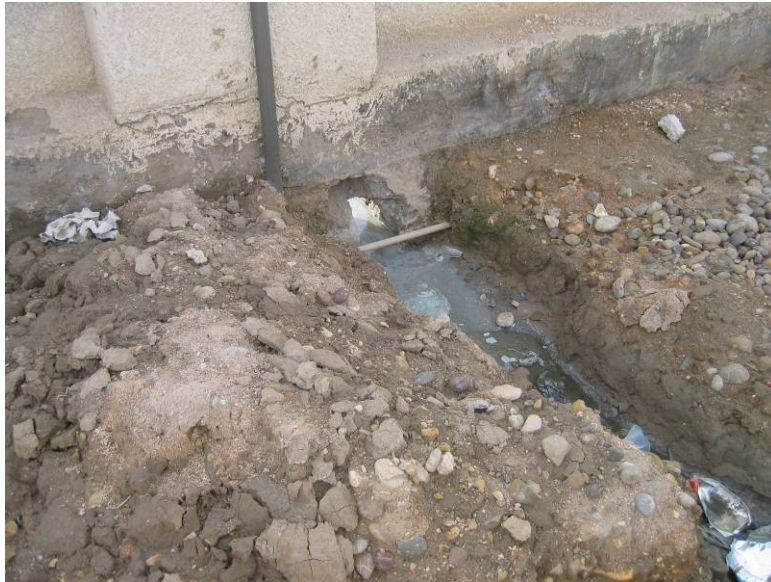
Site Photo 2. Raw sewage draining from the holding tank to the adjacent property.

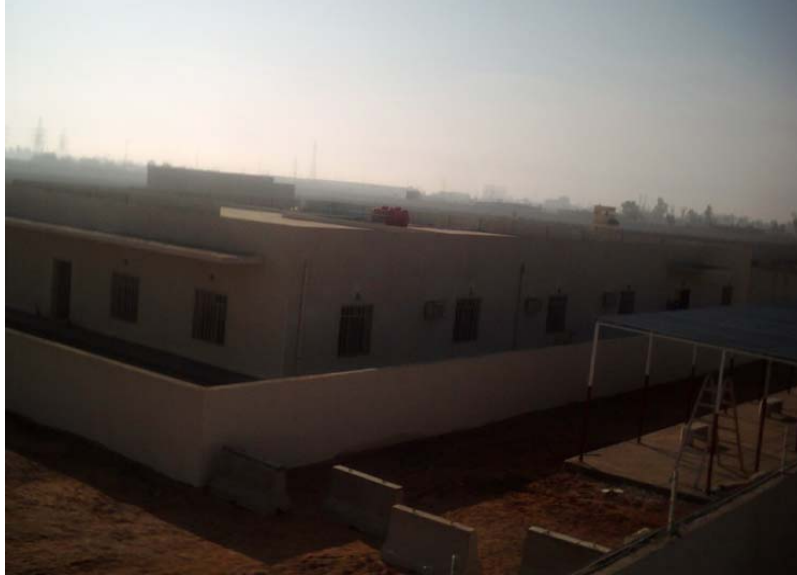
Site Photo 3. Jersey barriers blocking vehicle access to the building rear where the sewage holding tanks are located. (From Weston Photo Log)

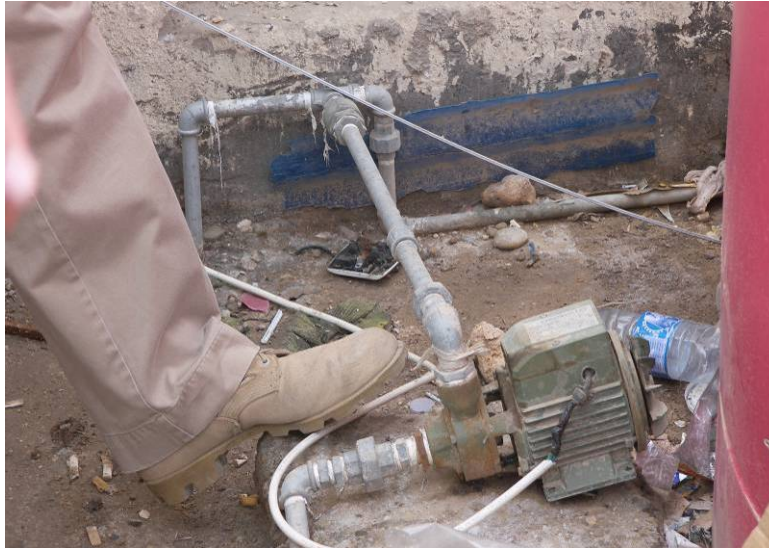
The contractor stated that the pumps were originally installed on the building roof but the current user moved them to the ground after occupying the facility. The contractor noted that all of the defects associated with the pumps' current condition are attributable to the end user relocating them from their original rooftop location. The contractor was unable to provide pictures or other evidence demonstrating the pumps were originally installed on the roof. Site Photos 4, 5, and 6 show the indoor wiring and electrical box, exposed water pumps, and disconnected wiring.

Site Photo 5. Water tank pump exposed to the outside elements

3. It is uncertain who is responsible for the unprotected water pumps and inferior wiring. Action should be taken to insure that outdoor wiring is installed, the water pumps are protected from the elements and the disconnected pump is connected to a power source.

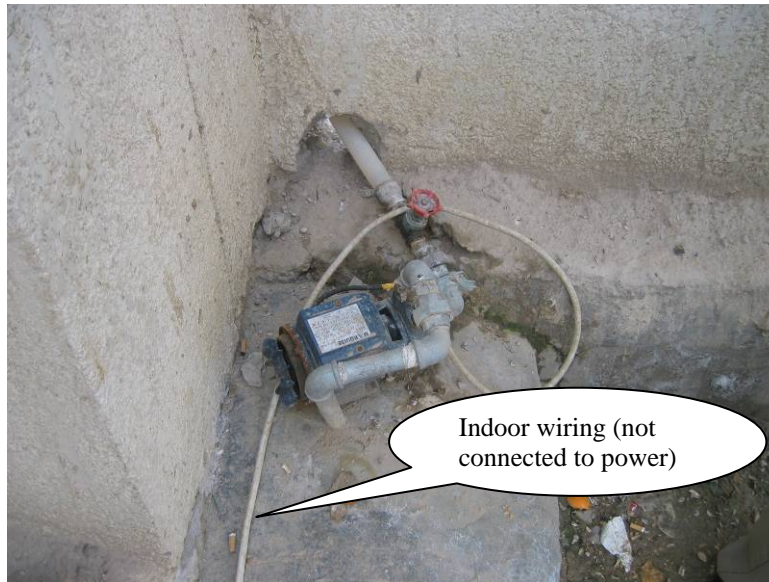
Site Photo 6. Exposed water pump connected to the main water supply line using indoor wiring. (Wiring is not connected to electrical power.)

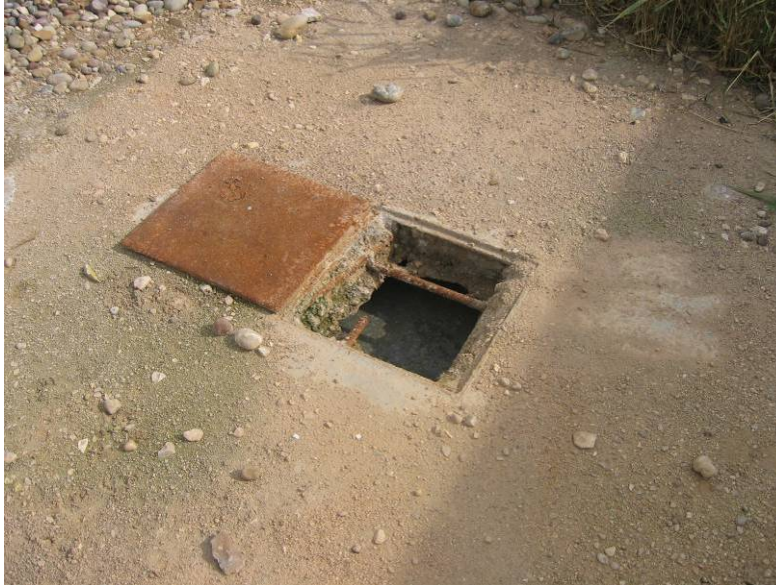
Site Photo 10. Sewage holding tank filled to capacity and draining to the adjacent lot

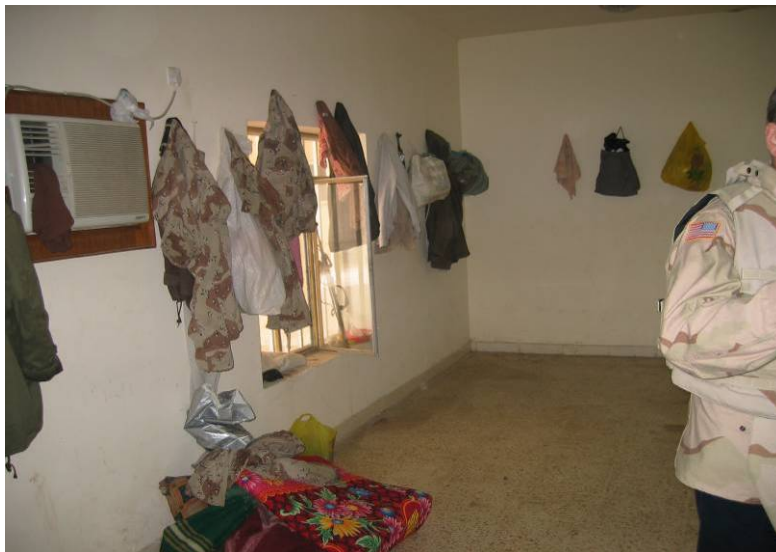
Site Photo 11. Bedless sleeping quarters for the Iraqi soldiers assigned to the facility.

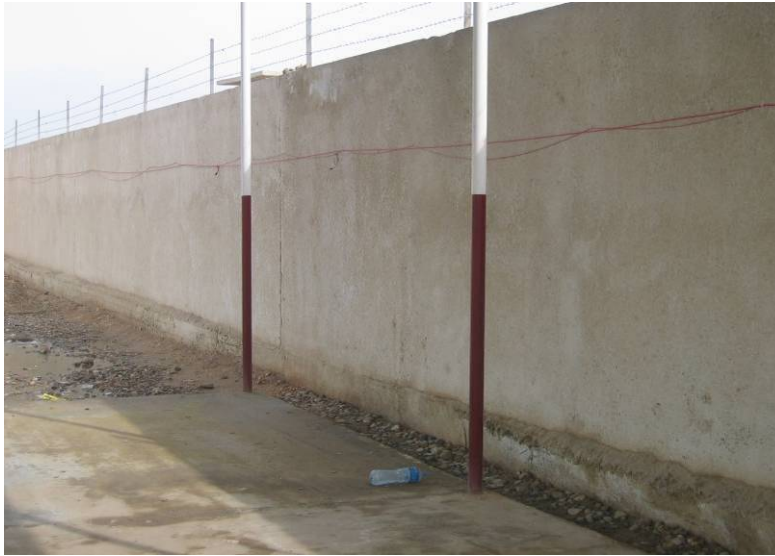
Site Photo 12. Post construction indoor wiring added to power the lighting for the outside staging area.

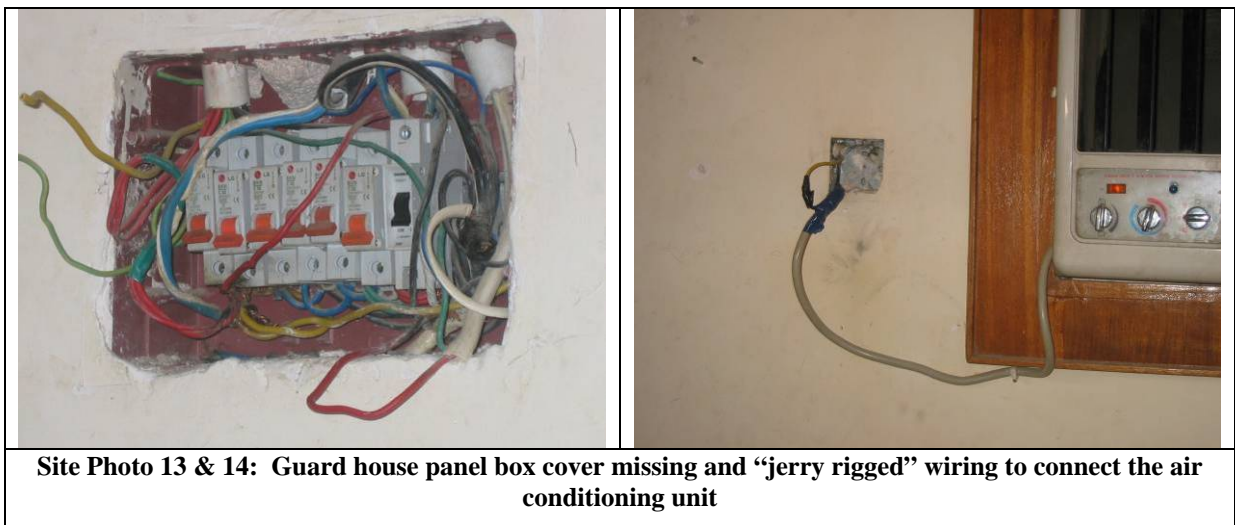
Site Photo 13 & 14: Guard house panel box cover missing and “jerry rigged” wiring to connect the air conditioning unit
